Leiwater
MONTAGU

Flood damage and progress of repairs
Part 5
21 November 2024

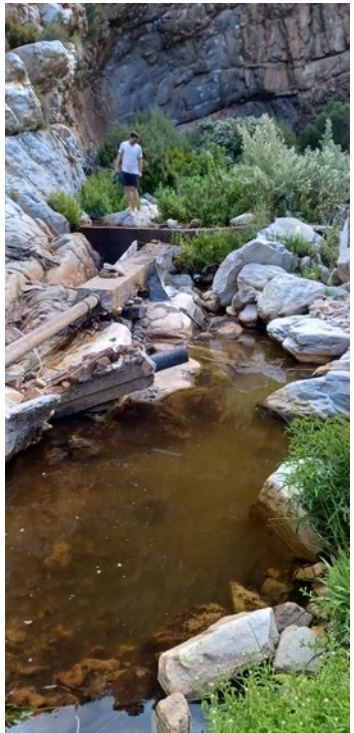
In October 2024, after waiting for the municipality to fix the road, we went in an fixed the road ourselves so that we could get to the higher weir.

We cleared the river, and started to repair and replace the sections of pipe that had been washed away. *Photos: Richard Knipe*

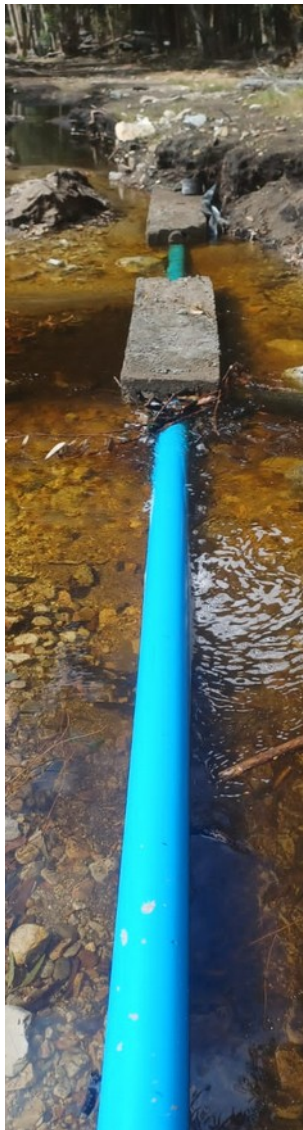
We then brought in the pipes and started laying them, boxing them in concrete as we went along. *Photos: Richard Knipe*

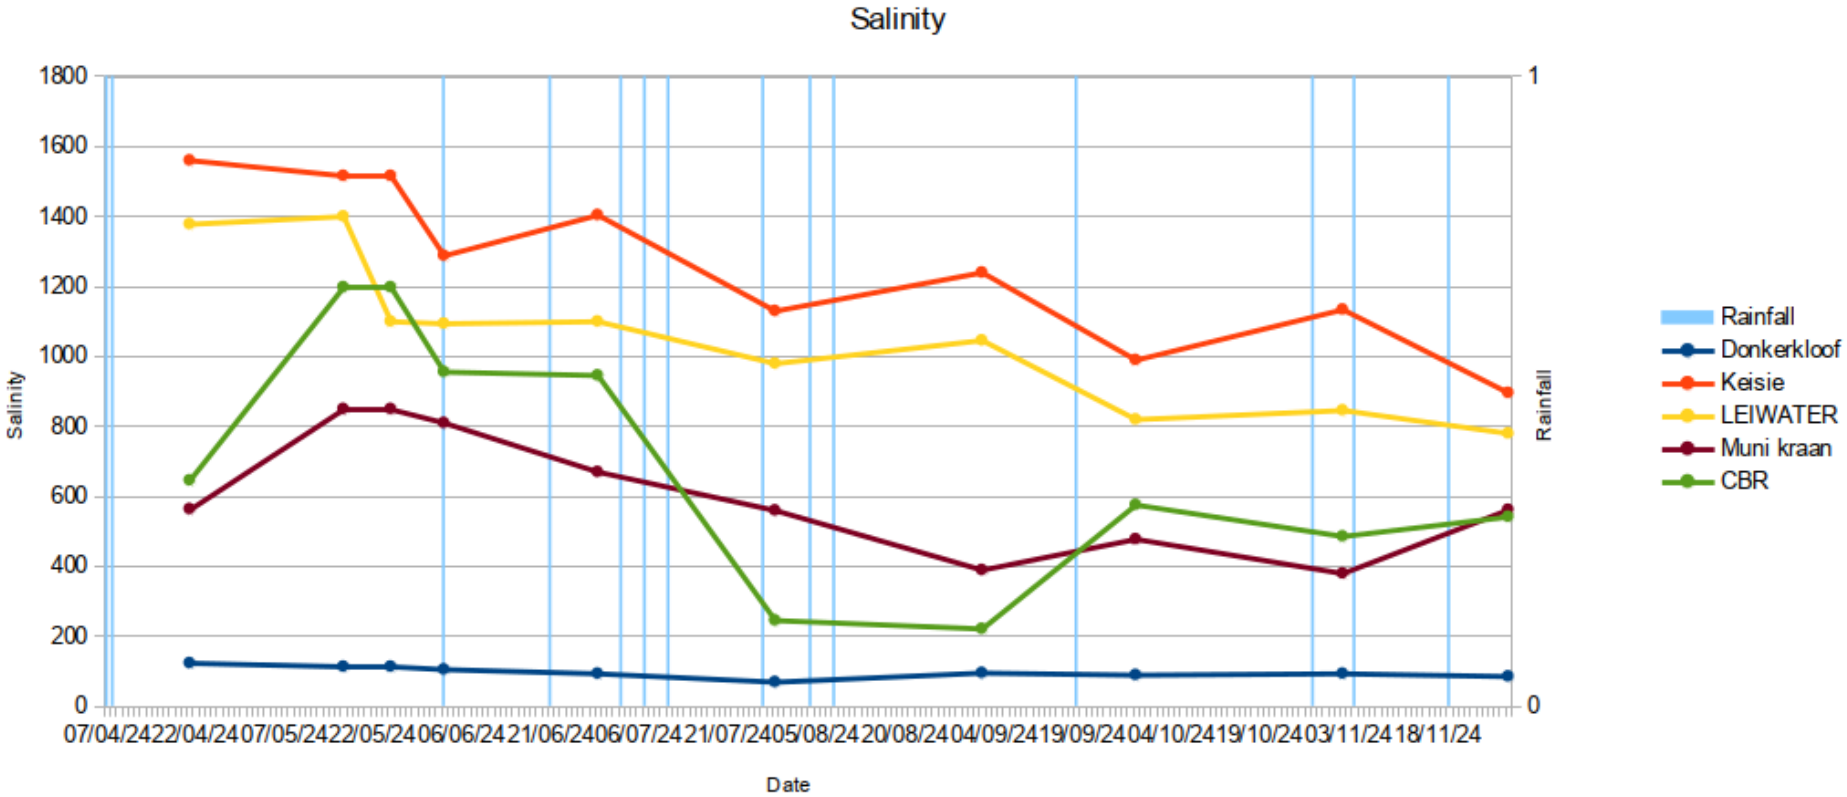
The Donkerkloof water component of leiwater is now about 50% (the other half from the Keisie River) which makes the water much sweeter and better for irrigation.

The salinity graph shows how Donkerkloof water remains sweet regardless of flood or drought. The Keisie water improves with each large rainfall event (> 10 mm).

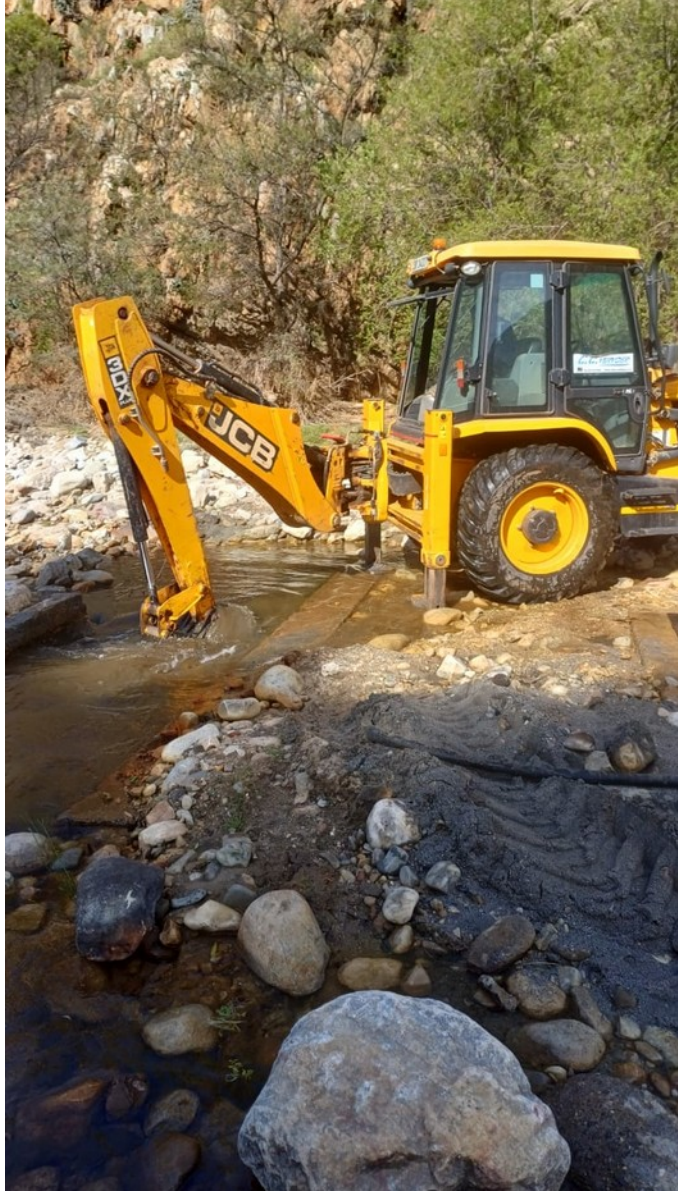
April & August 2024 – clearing silt from inkeergat. Two covers disappeared (probably theft because the covers were too heavy to move far in water).
